# ANNUAL REPORT FOR 2010

**Jinnys Branch Mitigation Site  
Brunswick County  
TIP No. B-4031**

Prepared By:  
Natural Environment Unit & Roadside Environmental Unit  
North Carolina Department of Transportation  
August 2010

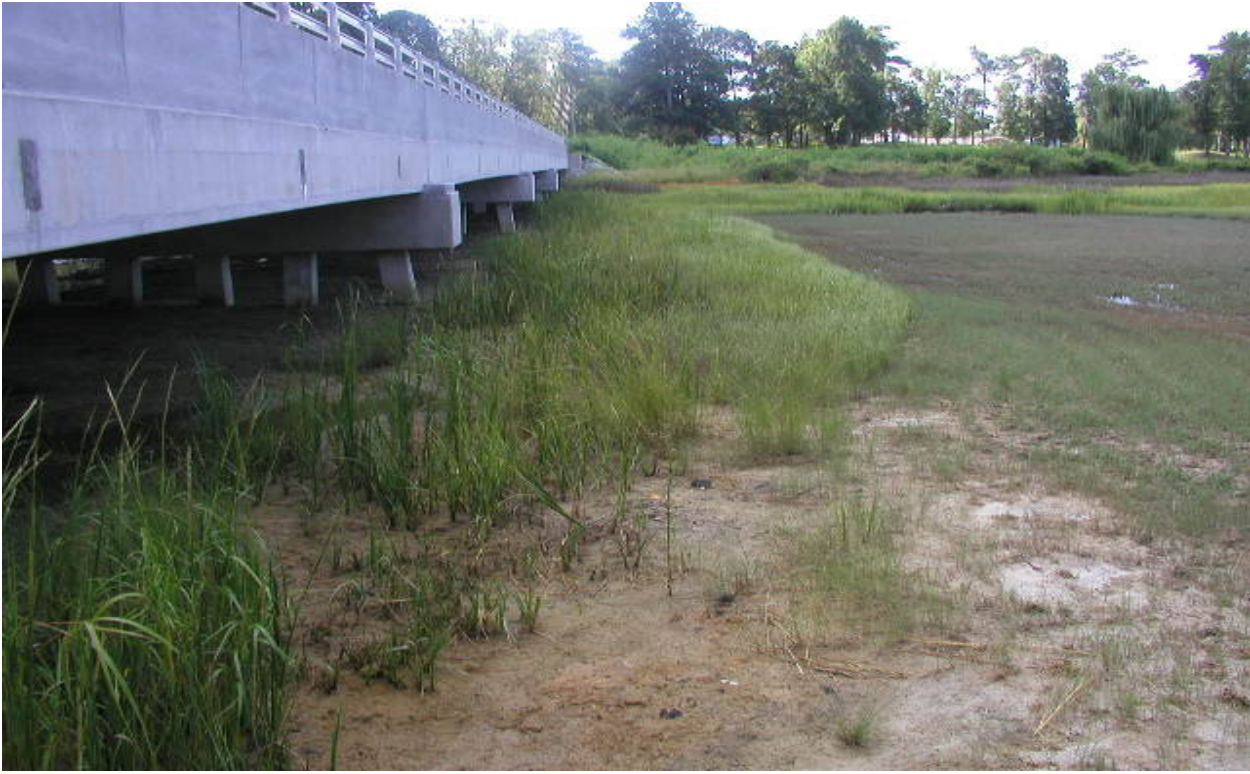
Photo 1 (Northern Approach)

The wetland restoration area is re-attaining jurisdictional status and the planted species are surviving in the planted areas. Vegetative coverage has increased since last year comparing 2009 to 2010 site photos. Other species noted within the restoration area include saltgrass, black needle rush, and marsh-elder.

NCDOT proposes to continue vegetation monitoring at the Jinnys Branch Mitigation Site.
